European Maritime Safety Agency: Leveraging Earth Observation Services to Support the Combat Against Environmental Crime

Earth Observation Services

ESRIN/ 11 June 2024

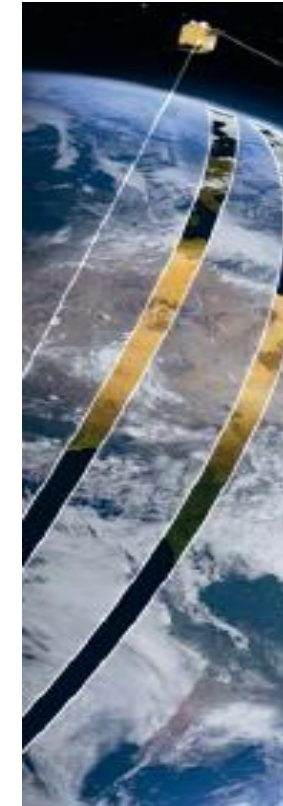
CleanSeaNet is the European satellite-based oil spill monitoring and vessel detection service. It analyses images, mainly from synthetic aperture radar (SAR) but also from optical missions, to:

- detect possible oil on the sea surface, including illegal discharges of mineral oil
- identify potential polluters, and
- monitor the spread of oil during maritime emergencies.

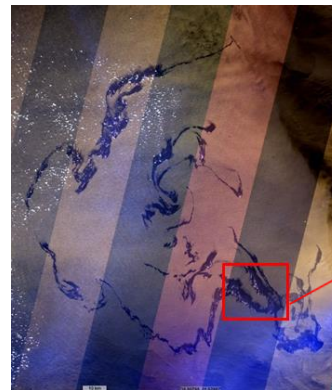
Copernicus Sentinel-2B over Red Sea oil spill
© Copernicus Sentinel data 2019

Oil Spill Volume (OSV) and Thickness estimation based on Sentinel-2 through a multispectral data analysis

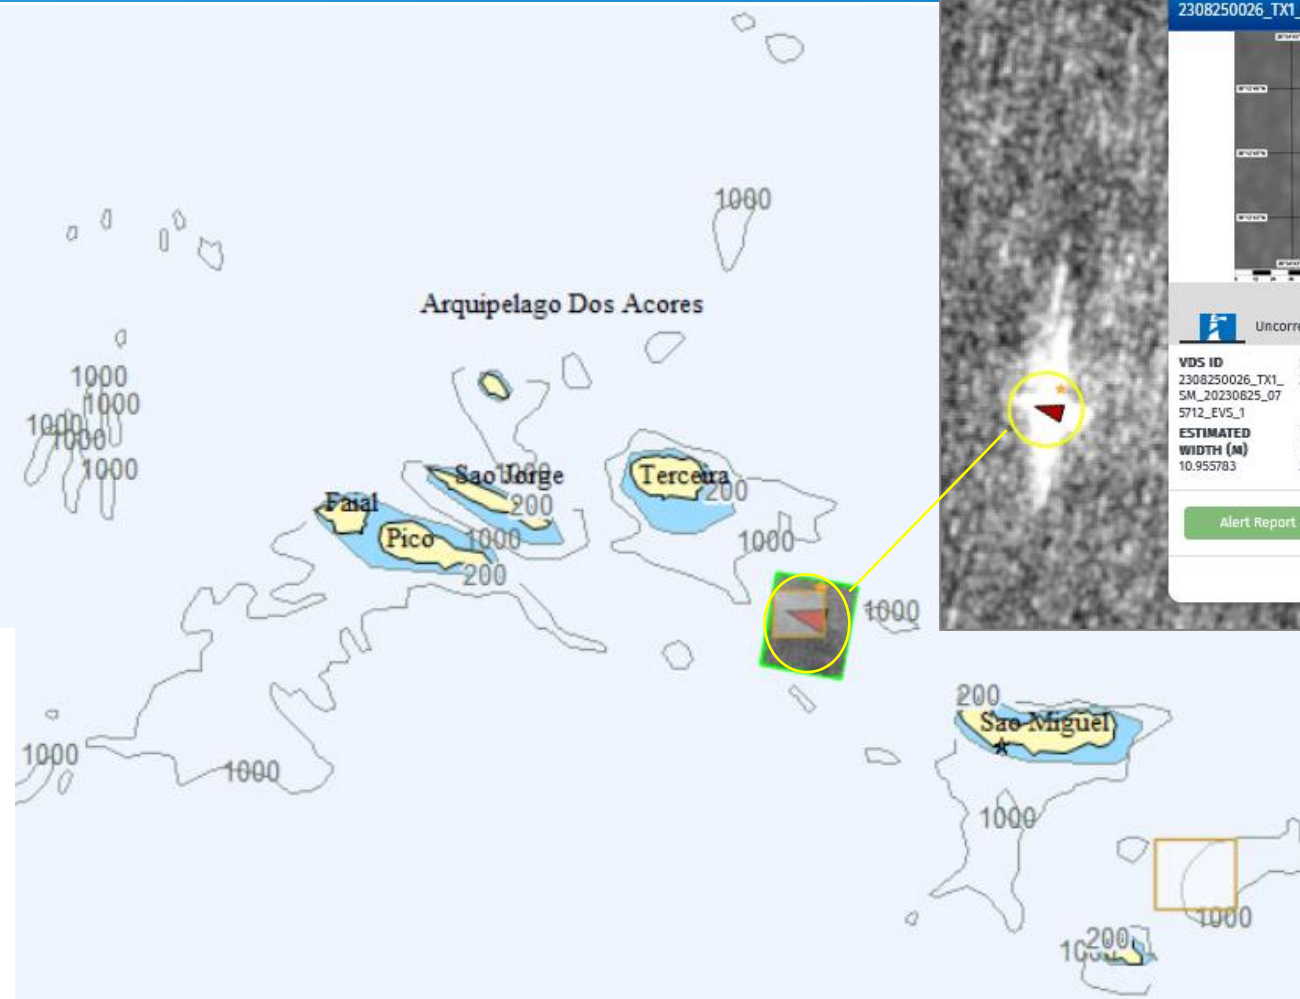
2308250026_TX1_SM_20230825_075712_EVS_1 2023-08-25 07:57:09Z

VDS ID	SERVICE ID	CONFIDENCE	ESTIMATED
2308250026_TX1_SM_20230825_075712_EVS_1	2308250026	LEVEL OF DETECTION	LENGTH (M)
		100	65.7347
ESTIMATED WIDTH (M)	ESTIMATED HEADING (°)	ESTIMATED SPEED (KNOTS)	
10.955783	285	N/A

Since 2017, CMS service supports monitoring of Marine Protected Areas (MPAs) in Azores.

With SAR satellite images delivered in quasi-real time, non-reporting vessels are detected that are further investigated to assess their potential involvement in illegal activities.

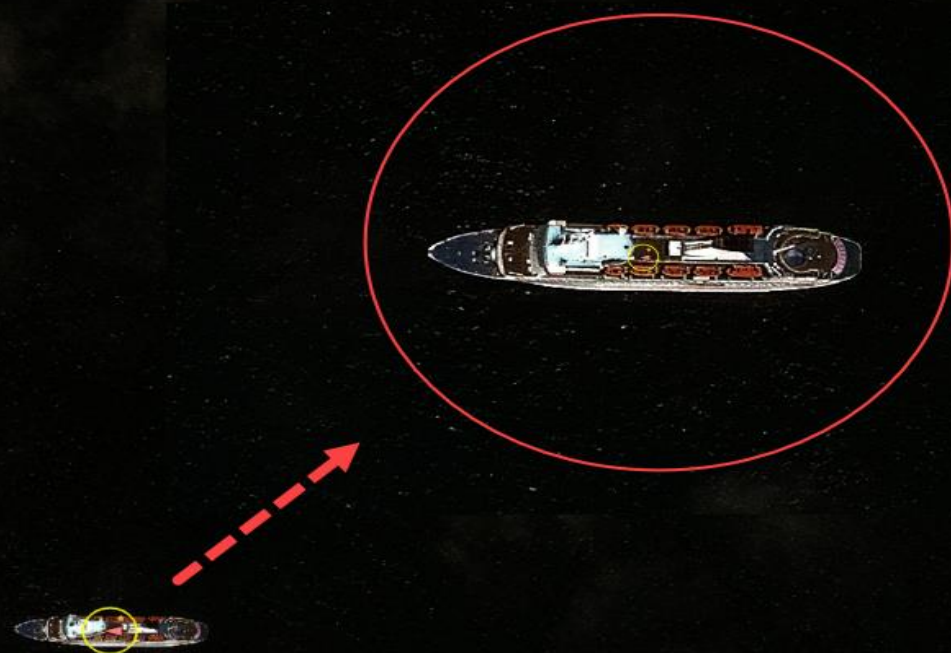
VESSEL ID	CONFIDENCE LEVEL OF DETECTION	VESSEL TYPE (FROM EO)
E1_PX_20220407_062419_EVS_7	75	PASSENGER SHIP:Cruise boat
SERVICE ID	LATITUDE (CENTER)	CONFIDENCE LEVEL OF TYPE (FROM EO)
	25°06'43"N	75
ACQUISITION START	LONGITUDE (CENTER)	
2022-04-07	066°39'47"E	
CORRELATED		
Yes

Investigation over a suspicion of shipbreaking of a cruise ship, near the beach of Gadani (Pakistan).

Optical CMS satellite images covered the area between the last transmitted AIS by the vessel and the shore (Gadani). The ship was detected and identified, allowing for a criminal investigation and procedure, to be conducted.
